Caisson Placement and Impoundment Material Characterization Impoundment 1 and 2 Pilot Study Operable Unit 8 - American Cyanamid Superfund Site

Prepared by: CH2M HILL OU8 Project Team

Date: November 26, 2013

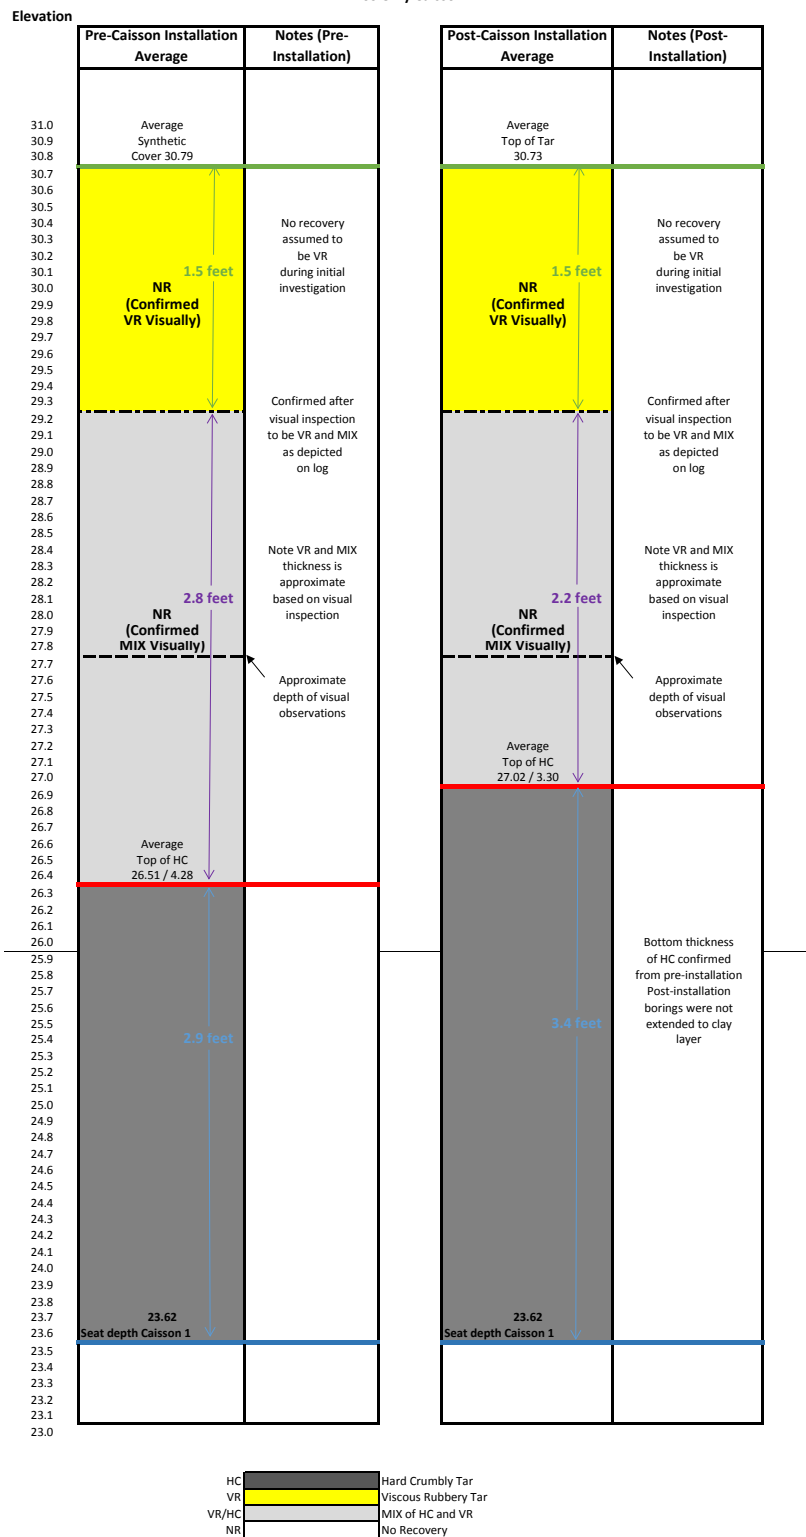
Caisson 1 Profile - Pre- and Post-Caisson Installation Summary
American Cyanamid Superfund Site
QU8 Pilot Testing

- Caisson #1 Location – Prior to installation of the caissons, an average of 4.3 feet of no recovery was seen. This average is based on three of the four boring locations, as the fourth location had no recovery in the entire length of the boring. Below the area of no recovery, an average of 2.9 feet of HC was identified to the bottom of where the caisson was ultimately set.
- Caisson #2 Location – Prior to installation of the caissons, an average of 6.4 feet of no recovery was seen, followed by an average of 1.2 feet of HC to the bottom of where the caisson was ultimately set.
- Caisson #3 Location - Prior to installation of the caissons, an average of 4.4 feet of no recovery was seen, followed by an average of 2.9 feet of HC to the bottom of where the caisson was ultimately set.

- Caisson #1 – In caisson 1, the liner appears to have torn as expected and the profile of the material is consistent with the profile seen prior to caisson installation. There is approximately 7 feet of material within the caisson based on the logs completed after installation, which is consistent with the total depth seen prior to caisson installation.

- Caisson #1 – After caissons installation, an average of 3.7 feet of no recovery was seen. Below the area of no recovery, an average of 3.4 feet of HC was identified to the bottom of the caisson. These thicknesses were consistent with the thicknesses seen prior to installation (4.3 feet of no recovery and 2.9 feet of HC). It should be noted that the tar depth was approximately six inches thicker when the original measurements were collected, but were near the same elevation when visual inspection was completed as documented below.

- Caisson #1 – The material from 0.0-1.5 feet was VR; and the material from 1.5-3.0 feet was MIX.
- Caisson #2 – The material from 0.0-1.5 feet was VR; and the material from 1.5-3.0 feet was MIX.
- Caisson #3 – The entire profile from 0 to 3 feet was MIX.

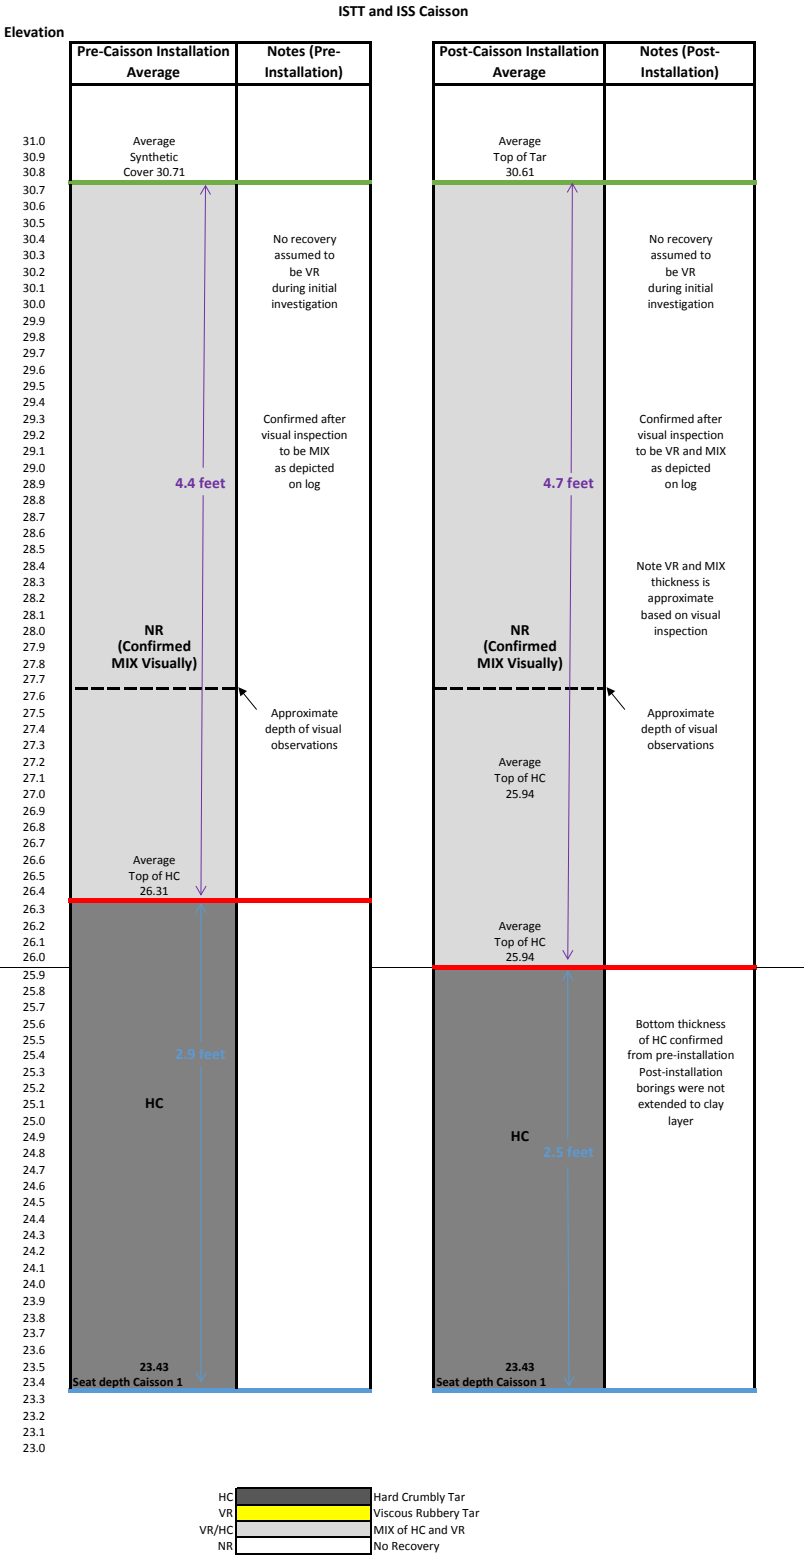
Figure 3
Caisson 3 Profile - Pre- and Post-Caisson Installation Summary
American Cyanamid Superfund Site
OU8 Pilot Testing

- Caisson #3 – As with caisson 2, there was approximately 4 feet of material in the caisson two days after installation. Remnants of the liner were also found in this caisson. It was difficult to tell through manual field probing if the 4 feet of material was VR, HC, or MIX.

- Caisson #3 – After raising caisson #3 approximately 58 inches off of the Flexifloat deck, approximately 1 foot of material re-entered the caisson after the first day of recovery. The caisson was lowered, lifted again to approximately 2 feet off the Flexifloat deck, and left in this position over the weekend of November 9-10. On November 11, 2013, the material level was observed to be approximately 7 feet, the same thickness as prior to installation.

- Caisson #3 – After caisson installation, an average of 4.7 feet of no recovery was seen. Below the area of no recovery, an average of 2.5 feet of HC was identified to the bottom of the caisson. These thicknesses were consistent with the thicknesses seen prior to installation (4.4 feet of no recovery and 2.9 feet of HC).
